A Layered Conservation Response to the Layers of Built History

Tanya Bezuidenhout and Graeme McConchie

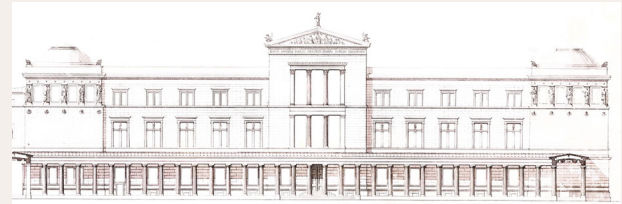
Figure 1. Neues Museum southwest façade, drawing of Friedrich Stüler's 1859 design. Source: Wikimedia Commons (author unknown)

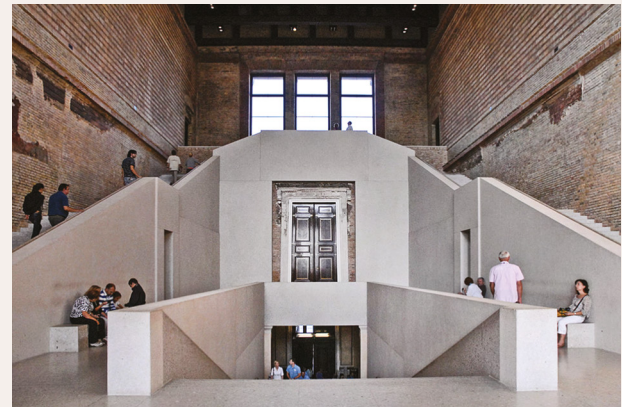
Figure 2. Neues Museum, completed staircase hall echoing the form of the original. Photograph: Jean-Pierre Dalbéra. Source: Wikimedia Commons. Licenced under Creative Commons Attribution 2.0 Generic Licence.

Addressing the lost west wing of the museum had a simple solution: to re-establish the form. Chipperfield supported this by saying, “it doesn’t make sense not to re-establish the form – it would be like a Greek sculpture with the missing arm. It’s one thing not to put the arm back, but it would be funny to add something that wasn’t there in the first place.”⁹ It was about re-establishing and honouring what had been. Chipperfield did this by working with the footprint, scale and masonry materiality of the lost element to recreate the overall formal symmetry of the building; but with simplified detailing at the roof cornice and around

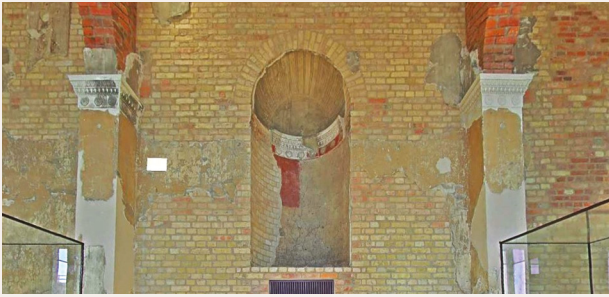
Figure 3. Ethnological Room, showing minimal intervention, retaining traces of the original wall colour and previous restoration work. Source: Google Maps

The ICOMOS Charter describes preservation as a way to ensure a building’s long-term survival, which involves as little intervention as possible through the means of stabilisation, maintenance and repair.⁷ The Ethnological Room in the southwest corner of the Neues Museum demonstrates the way in which preservation can reveal a sense of rawness in the space, seemingly only touched by the hands of time. There is no attempt made to repair the broken capitals or the cracked plaster, or to retouch the faded paintings on the wall. The space is unapologetically honest about its age, history and the trauma it experienced that has come and gone. The only moments of intervention that are visible are in the essential stabilisation and support for the weakened plaster. Applied in areas with superficial damage, Chipperfield’s ‘soft restoration’ method aims to memorialise rather than suppress and hide the damage caused by post-WW2 decay and weathering. Decayed areas were painted in a colour a shade or two lighter than the original, which created a variegated effect. It was never the intention to restore the surface to a completed state, but rather to a state that could be perceived as complete. Close inspection of the surfaces would reveal the colour difference, and also the texture of the surface continues to display the decay, ensuring historical legibility. Reconstruction is defined by the ICOMOS Charter as a form of restoration involving the introduction of new materials to replace what has been lost. This is considered an appropriate conservation method if reconstruction “is essential to the function, integrity, intangible value, or understanding of a place.”⁸ Reconstruction was used by Chipperfield in spaces where the architecture was integral to the exhibit, as it was in the Roman Room. In an advanced state of decay, the Roman Room had only fragments of the plaster remaining on the walls and ceilings. When reconstructing the missing elements such as the decorative mouldings and capitals, it was important for the reconstructed material to provide a neutral backdrop to the surviving original material. Working with a muted colour palette provided context for the surviving fragments, allowing visitors to experience the space as it once had been, yet with subtle evidence of what had been reconstructed.

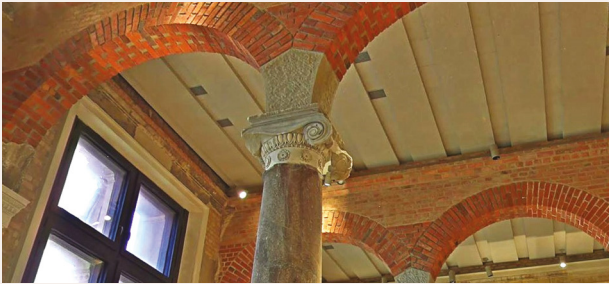
Figure 4. Ethnological Room, Ionic capital with deliberately retained damage. Source: Google Maps

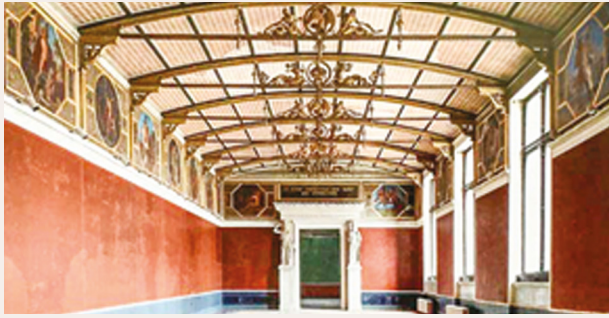
Figure 5: Room of Niobids, with previously weathered areas of wall retained. Source: Google Maps

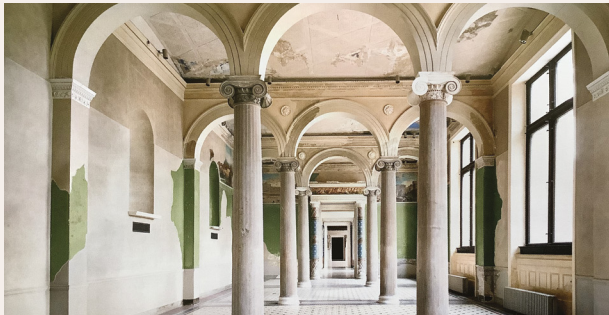
Figure 6: Roman Room, with reconstructed detail. Source: Google Maps

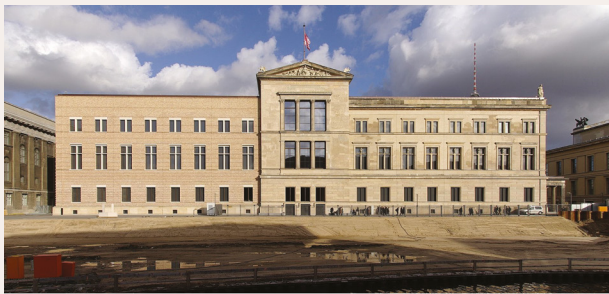
Figure 7. Southwest façade of the Neues Museum. Photograph: Janericloebe. Source: Wikimedia Commons

window openings, offering light but recognisable distinctions between the new and the existing. As mentioned earlier, the different conservation intervention strategies may have varying levels of permanence and legibility within a building. This is something that is clearly evident in Chipperfield's response to the Neues Museum – convincing evidence of his detailed analysis of different spaces and surfaces, deciding which elements are important in providing a context of understanding for historical legibility, and then developing

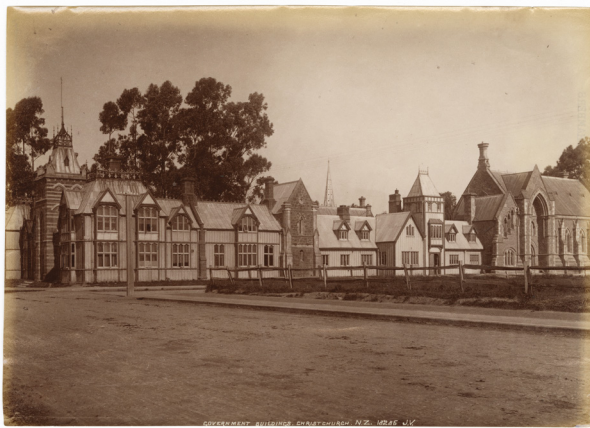
Figure 8. Completed Provincial Council Buildings, ca.1870 (Armagh Street Tower, far left, and Council Chamber to the right). Source: *Christchurch Star* archive and Christchurch City Libraries

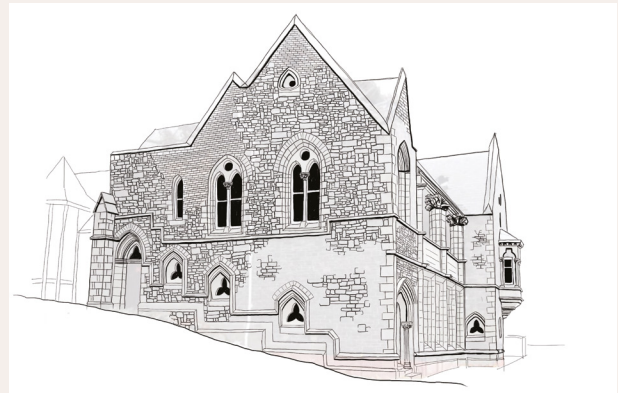
Figure 10. Perspective of Bellamy's illustrating selective reconstruction with new masonry. Drawing: Tanya Bezuidenhout

There were two levels of intervention: minor and major. Minor interventions focused on sections of the buildings that suffered the least amount of damage or had been dismantled after the earthquakes. The exterior walls of Bellamy's suffered a partial collapse, and the initial conservation response could have been to restore walls to their previous state, hopefully by recycling fallen stones. However, it was proposed, in acknowledgement of this moment of history, to reconstruct the fallen areas of the exterior walls out of a similar, but not identical stone, coursed in a more regular construction pattern. This would allow the reconstruction to sit sympathetically within the surviving stonework, while maintaining honesty about being a new material and revealing the scars from the earthquake. Major interventions responded to sections of lost fabric and new moments of growth, within and in addition to the existing building fabric. As mentioned previously, the Stone Chamber had one of the finest High Victorian Gothic interiors. The greatest loss of the Provincial Council Buildings during the earthquakes was this interior space; in particular, the highly decorated ridge-and-furrow ceiling. With so much of the material lost following the earthquakes, it was essential to find an appropriate conservation response that would not only honour the layers of the building's history, including the earthquakes, but also the aesthetic and historical significance that was associated with the interior of the Stone Chamber. Two approaches were considered. The first could be likened to Chipperfield's approach of 'soft' restoration. Only a small number of the panels of the ridge-and-furrow ceiling had survived the collapse of the Chamber. The gaps left after reinstating the surviving panels would be filled by new panels

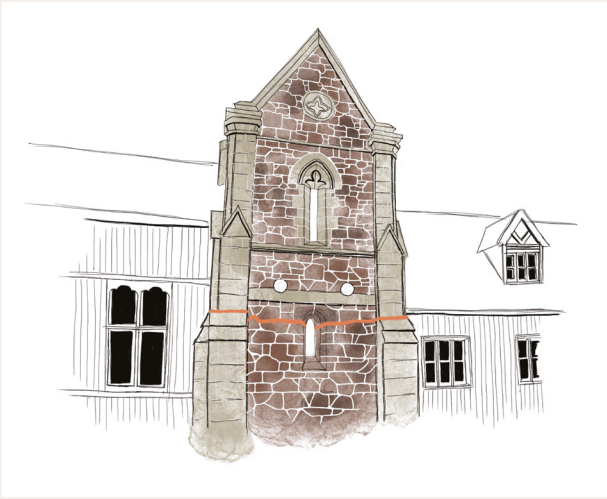
Figure 11. The substantially reinstated Durham Street Tower (above the line indicated). Drawing: Tanya Bezuidenhout

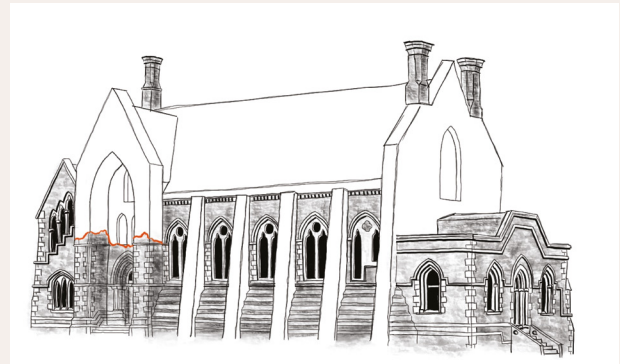
Figure 14. The reinstatement of material between the buttresses 'weaves' new and old elements together, respecting the overall history of the Stone Chamber. Drawing: Tanya Bezuidenhout

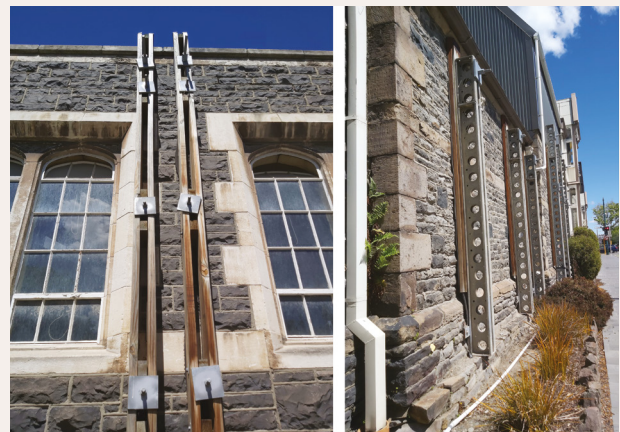
Figure 15. Selected retention of post-quake strengthening will provide tangible evidence of earthquake response. Photographs: Tanya Bezuidenhout

of the Stone Chamber's history, as well as the architectural features that contribute to its significance. It became clear that, as with the Neues Museum, conservation responses to the damage of the Provincial Council Buildings are varied, with multiple solutions being appropriate. There is a driving focus on honouring the collective legibility of the multitudinous layers of the building's past; including the ten-year period since the earthquakes, through the deliberate retention of some of the post-earthquake 'temporary' support provided to surviving stonework.
